PHOTOS FROM THE JAZZ TIMBER SALE, Scoping 2010

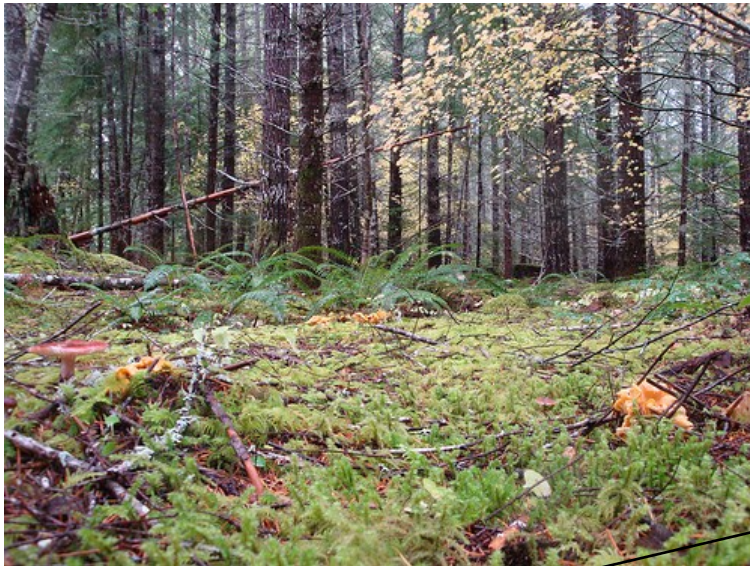
We also have found an abundance of mushroom species in unit of the proposed timber sale this season, indicating a healthy soil structure. We expect the Forest Service to be fulfilling all guidance for listed species under Survey and Manage to ensure protection for the rare species that may be present in this area.

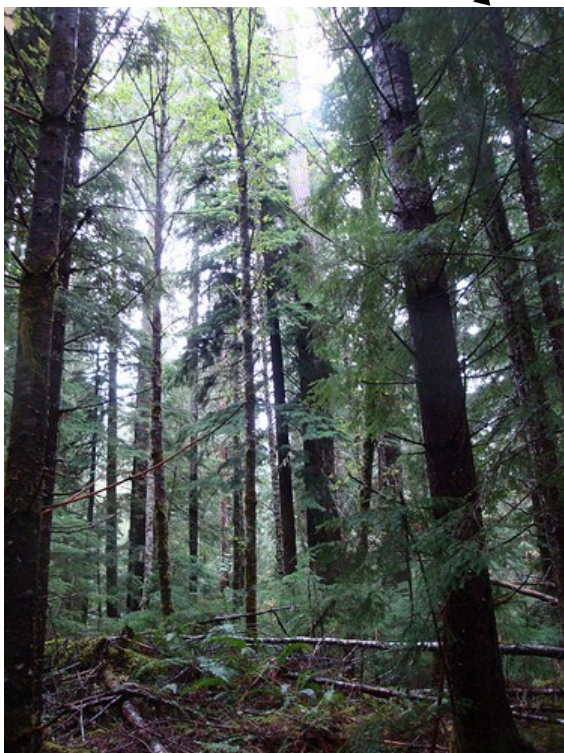
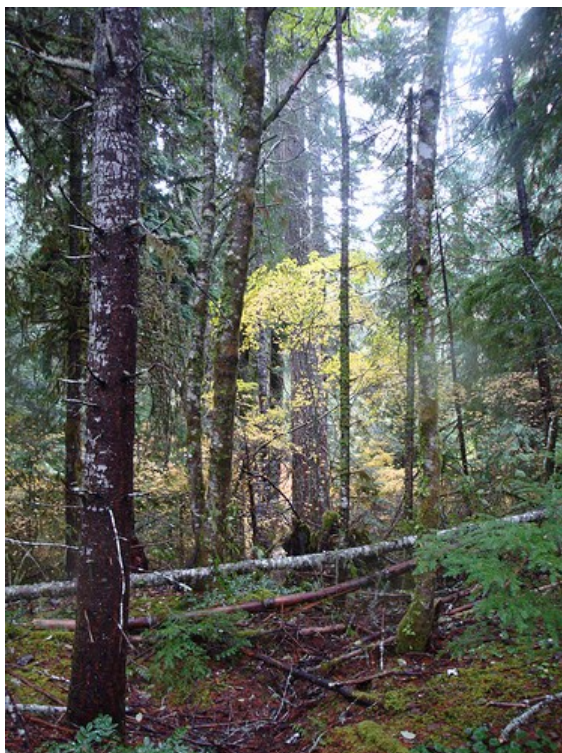
Like all of the LSR units that are being proposed, Unit 4 is adjacent to healthy old growth forests. These units have forests that are recovering from past logging and benefitting from the healthy and diverse forests around them. **We strongly urge the Forest Service to drop all units that are in LSR.** These photos show what we believe is the edge of the unit looking into the transition to older, mature forests.

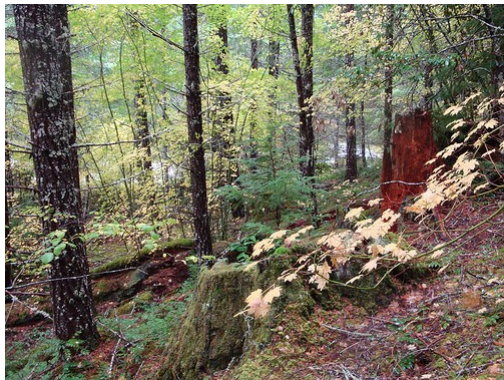
Unit 2 is surrounded on all sides by wetland and streams. **How does the Forest Service expect to avoid impacts into this important drainage into the Cap Creek?**

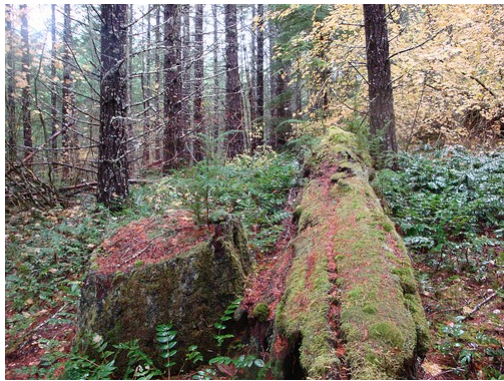
The level of downed woody debris, here in unit 2, is left from both past logging and natural decay. It has provided a good diversity of biomass structure in the plantation forests.

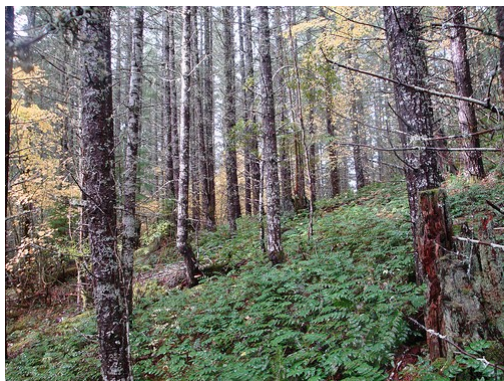
This image of Unit 2 shows one of the many indicators of high earthflow activity. The tree growing to the right in the picture is likely compensating for the movement of the slope that it is growing in, causing the bend in the trunk at the bottom.

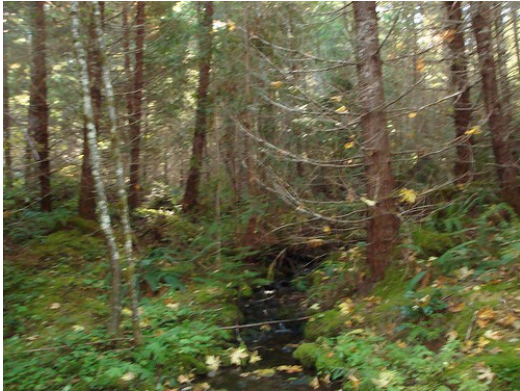
Stream in Unit 114. This unit is at the confluence of two drainages into the Collawash River. Like the other units with Riparian Reserve in them, this one has several streams not accounted for on the unit map provided to the public.

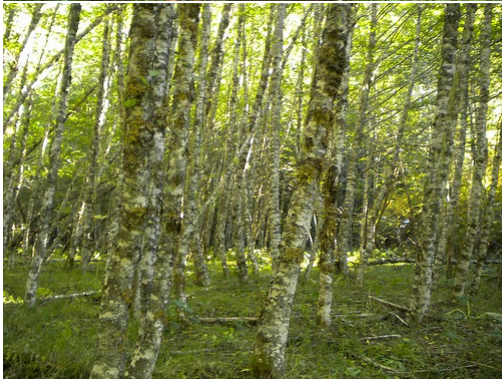
This wetland and red alder stand is adjacent to Unit 34 and is not accounted for on the map. These alder stands provide stability for shifting earthflow areas, but will not hold up to high levels of windthrow. Should logging occur, we have concerns about the loss of this stand from the increased exposure to wind.
