BARK PO Box 12065 Portland, OR 97212 www.bark-out.org 503-331-0374

February 26th, 2016

RE: Goat Mountain PA comments

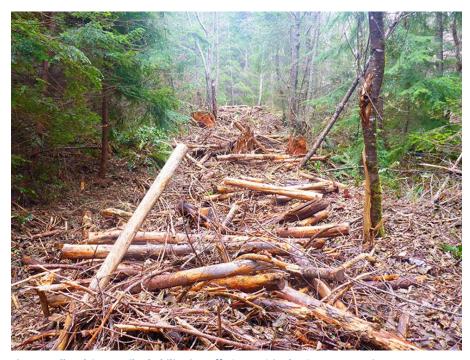
Figure 1: Illegal OHV trail rehabilitation off FSR 4510 in the Goat Mtn project area

Some road closure and trail rehabilitation projects completed recently within the Goat Mtn. project area have been effective in reducing unauthorized target shooting, OHV use, and garbage dumping in stands proposed for thinning (Fig. 1). Restoration actions have included boulders and slash

being placed along the road, berms, obliteration, recontouring/decompacting, re-vegetating, and the removal of trash.

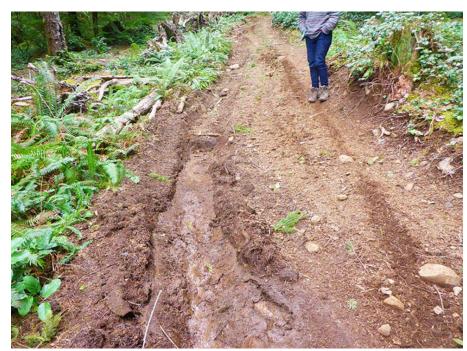
Illegal OHV trailbuilding has unfortunately persisted in the Hillockburn area of this project. There were at least two recent 2012/2013 Retained Reciepts projects in the Goat Mtn. area that went through CSP to address this issue road closures, road decommissioning, obliteration of illegal OHV trails (\$44,000

Figure 2: OHV damage at Goat Mtn Unit 38, which includes additional roadbuilding

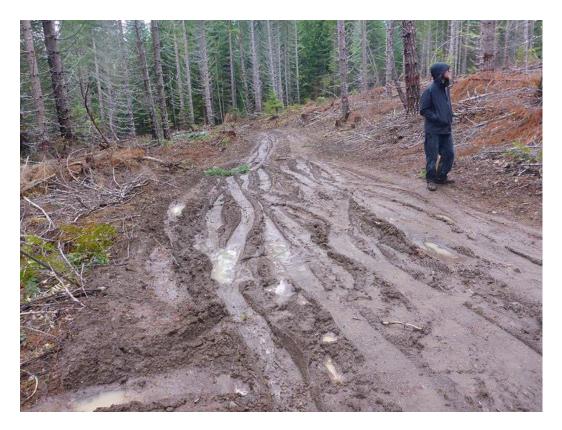
Some recent CRRD projects have resulted in either non-implemented closures resulting in ecological damage (Fig. 3 & 4), breached closures (Fig. 5), or circumvented closures on both temporary roads and on roads recorded as "decommissioned" in Forest Service documents.

Figure 3: Open temporary road into Jazz unit 30

Bark requests a commitment from the agency to enforce effective barricades on roads built or rebuilt for this project when operations are not occurring. *This includes time when the area is still under contract but outside the normal operating season.*

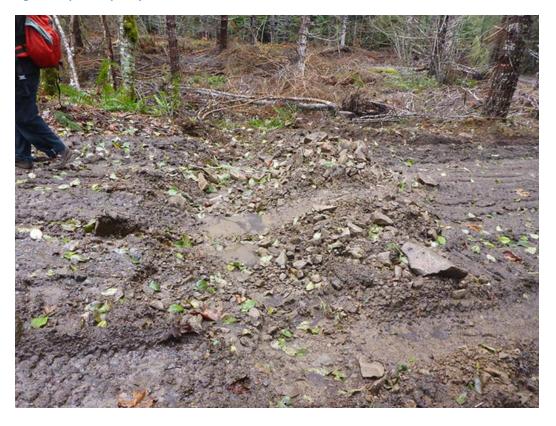
Figure 4: Road 6311-130 reopened as part of the Jazz Thin, unregulated access damaging erosion control measures

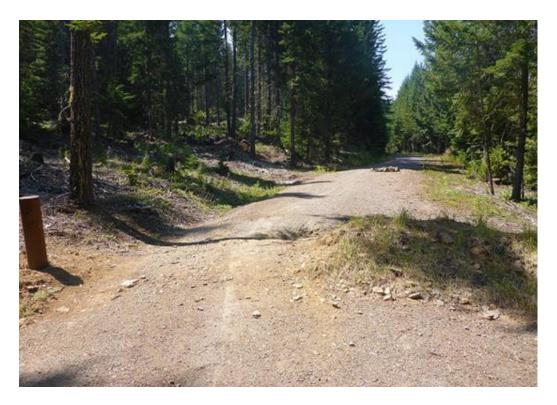
Figure 5: Breached berm on closed road 4660-140 (closed with Increment 2) in the Hunter project area

- After project implementation and before conclusion of the contract, fully implement and monitor effectiveness of Project Design Criteria D7 from Goat Mtn. PA in order to impede further damage from unauthorized motorized access to units after thinning has taken place. However, in addition to berm, consider placement of boulders close to the main road to further deter off-road access.
