RE: Grasshopper Timber Sale scoping comments round 2

4860 FUEL BREAK

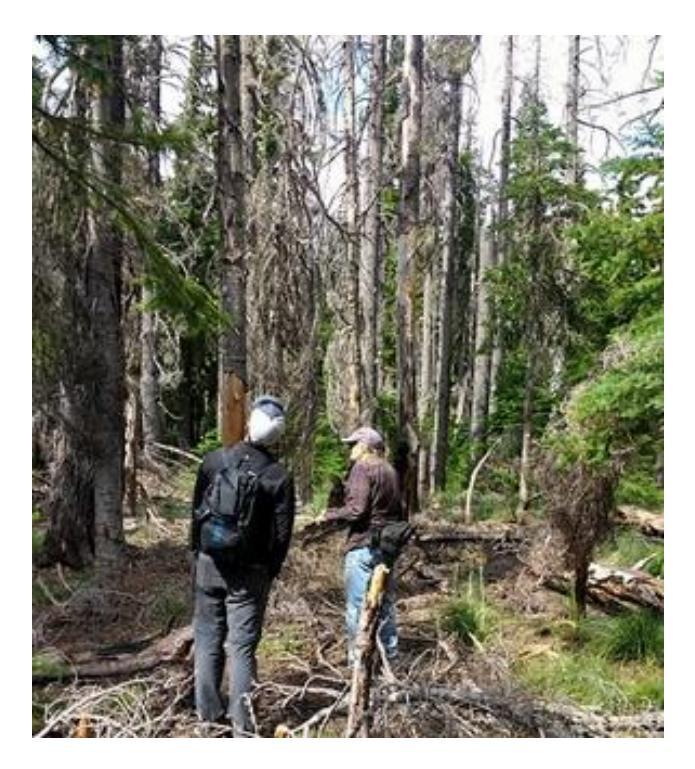
Unit 178 - small burn at 45°15'35.37"N, 121°32'8.44"W – it was unclear if this fire was human-caused

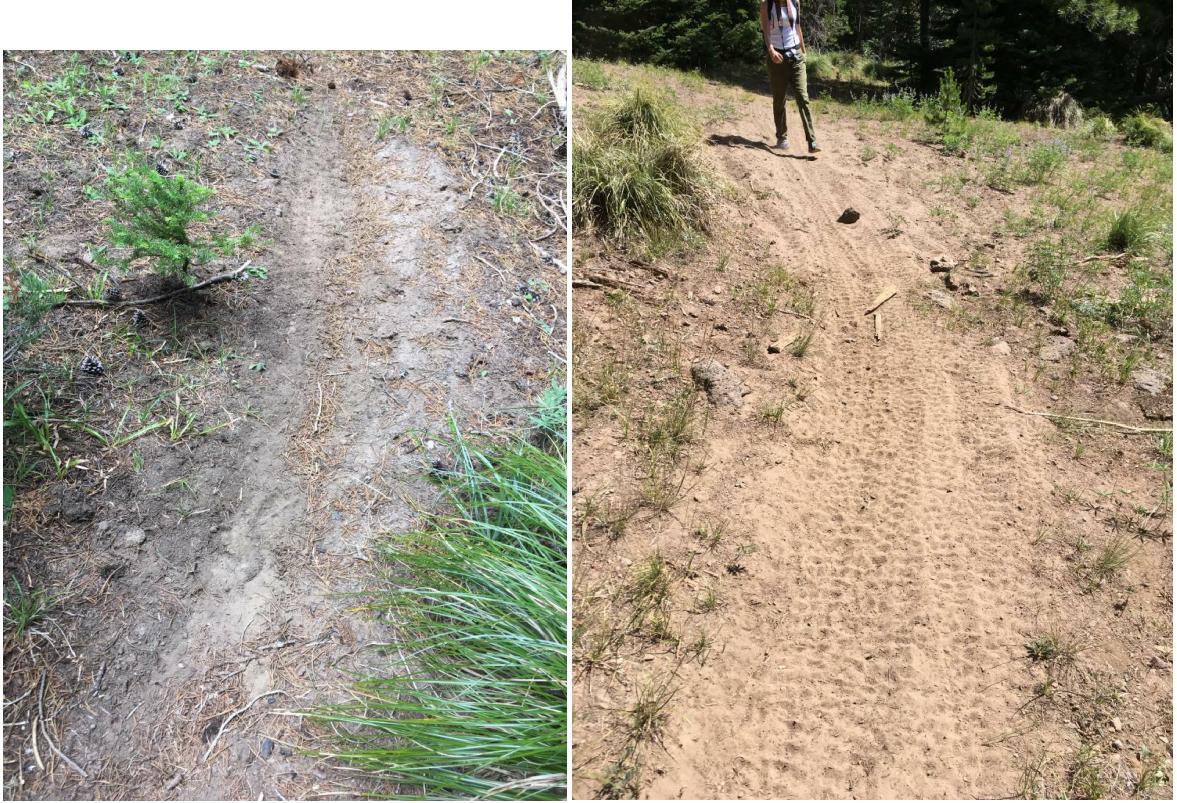
Along the 4860, we observed areas of illegal motorcycle use off the open system roads. This activity damages soils, disrupts wildlife, and increases the risk of unwanted, human-caused fire. Given the high probability that fire starts in the area would be human-caused, and the potential for increased access off the main road post-project implementation, the Grasshopper proposed action must include PDCs to reflect this reality.³

Illegal motorcycle activity at 45°15'11.16"N, 121°32'9.17"W (L); and at 45°15'6.63"N, 121°32'1.87"W (R)

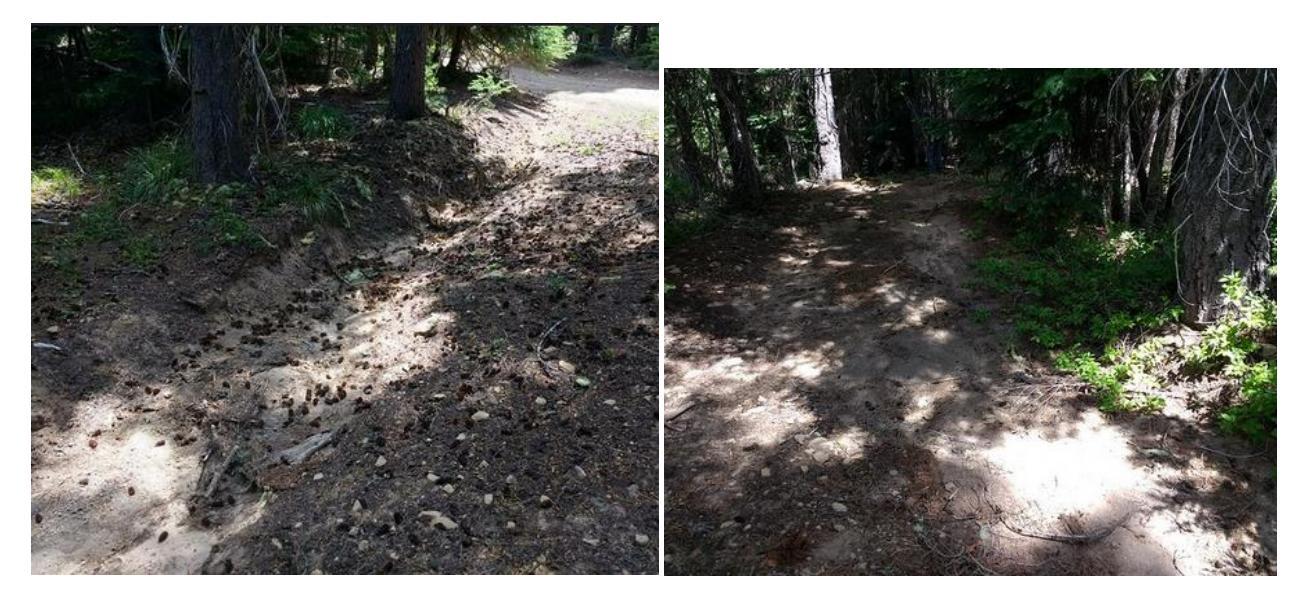
There are a few locations where runoff from the 4860 road is approaching acute levels. One such location is at Unit 163 pictured below. The road fill extends into the unit at least 20 feet and continues downslope. An effort should be made at this and other locations to divert water to flatter, more stable areas through use of re-grading, out-sloping, cross-drain culverts/inboard ditch/etc.

Road runoff/erosion from FSR 4860 45°15'58.91"N, 121°32'26.00"W

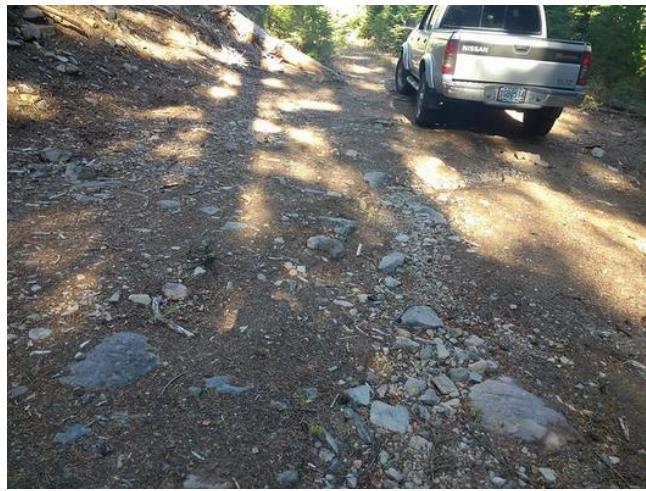
FSR 4880-015 is a high clearance, native surface road with low use. The road is blocked by fallen trees less than halfway to Unit 56. Once the road reaches unit 56 it intersects the wet areas and completely disappears. We recommend closing this road and decommissioning it if possible, as was proposed in the original Increment 3 process. **FSR 4880-014** is a similar situation and we offer the same recommendation there.

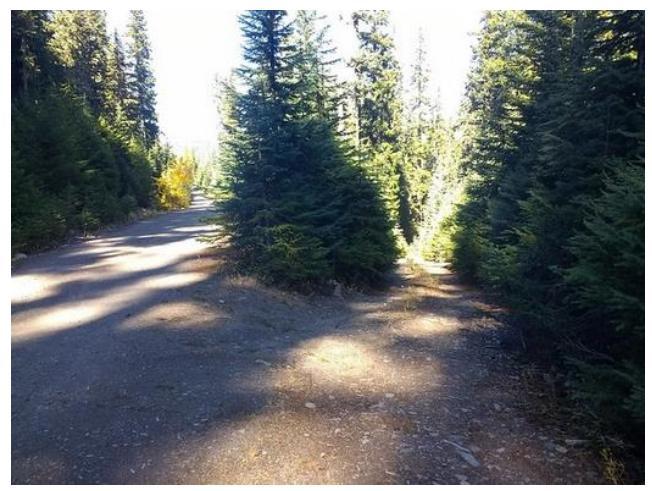
FSR 4880-014 entrance from 4880

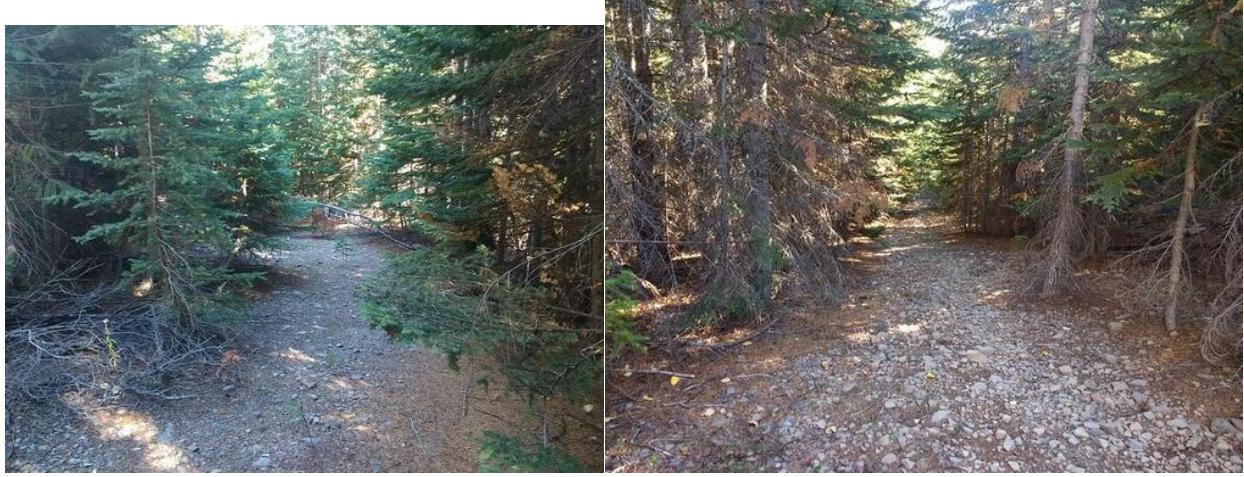
There is an old, unmapped roadbed directly adjacent to FSR 4880-014, on the same side of the road but headed south. This "ghost" road network should be actively decommissioned as it is not currently on the open system or calculated as a contributor to open road density.

Old roadbed unmapped, adjacent to 4880-014

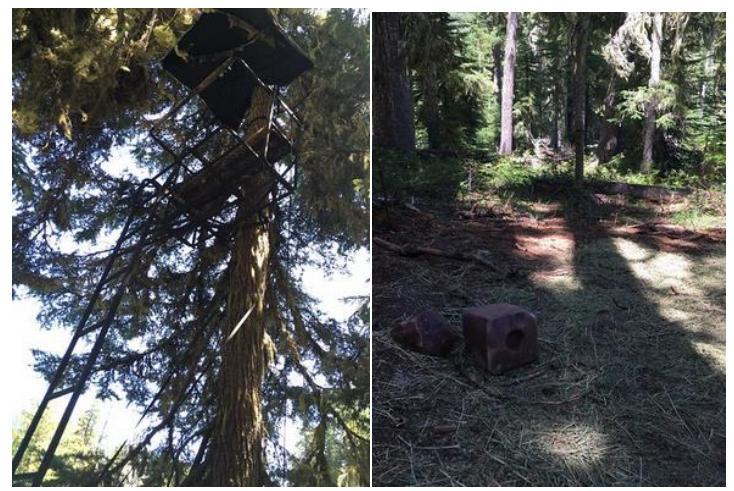
Bark volunteers noted an elaborate hunting stand in the valley surrounding Boulder Creek, at **45°16'31.07"N, 121°33'50.20"W.** The stand had salt licks and alfalfa spread around beneath it, and was erected in a permanent fashion, which is illegal. Please include removing this hunting stand from this location in a wildlife technician or other Forest Service employee or contractor's work for this upcoming year.

Hunting stand and bait near Boulder Creek
